## Turbine Duct Fairing Re-work

Maintenance of this Turbine Duct Fairing requires the replacement of worn bolts. The countersink needed to be re-worked.

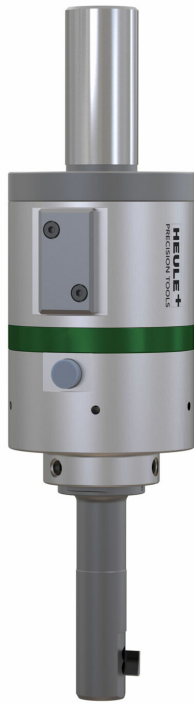
Thanks to a SOLO tool the counterbore can now be machined from the same side, eliminating the need to turn the part after drilling.

- Automated machining from one side.
- No complicated re-clamping of parts in the machine.
- **Consistent and reliable form-countersink machining**
- **Cost saving ~ USD 55'000 / year**
